ABB MEASUREMENT & ANALYTICS | SERVICE INSTRUCTION

ScreenMaster RVG200

Terminal block failures

ScreenMaster RVG200 terminal block

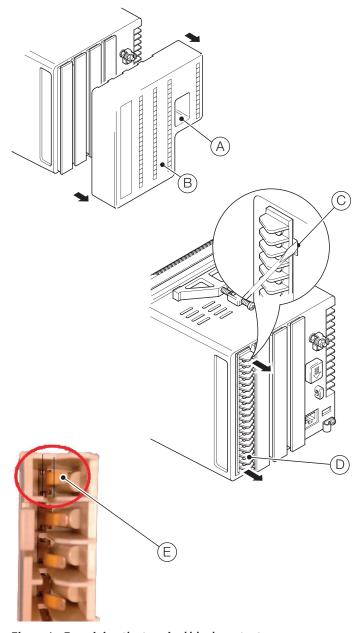
Figure 1 Examining the terminal block contacts

The reason for potential failure is that during installation, unscrewing the terminal connection, inserting the wire and tightening the screw can cause the spring assembly inside the terminal block to move, breaking its contact with the PCB.

The correct position for the contacts is as shown in Figure 1 – each contact must be positioned a minimum of halfway across the slot in which the module board fits.

- **5** If a contact is positioned incorrectly or is damaged, replace the terminal block assembly.
- 6 Fit the terminal block.
- **7** Refit terminal cover (B).
